STAFFORD, CONNECTICUT

WARREN POND DAM
00335

PHASE I INSPECTION REPORT
NATIONAL DAM INSPECTION PROGRAM

AUGUST 1980

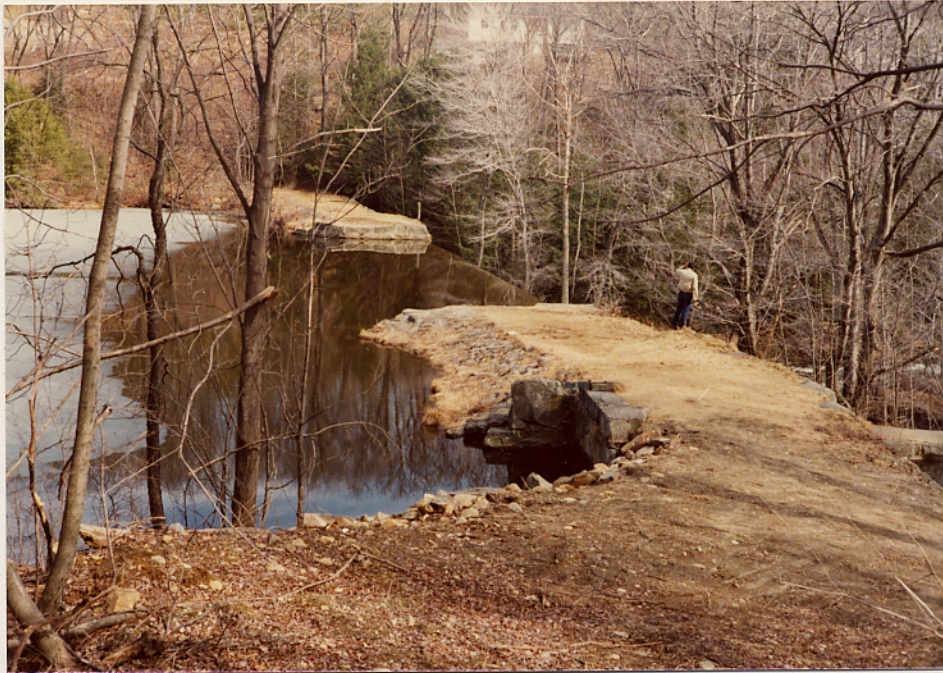
c. Appurtenant Structures - The masonry culvert through the right embankment section of the dam and the outlet canal are both in poor condition (Photos 1 and 3). There is no gate hoisting mechanism on the upstream headwall of the culvert. Fallen masonry blocks at the right corner of the upstream headwall of the culvert were observed, leaving exposed and eroded earthfill. The left masonry wall of the outlet canal, with concrete coping on the top, was deteriorated with numerous cracks in the concrete and opened, weathered masonry joints. There is a 12 inch cast iron drain pipe

Photo 1 - Upstream slope and top of dam. Upstream headwall of canal intake culvert in foreground (3/24/80).

6. The cracked and damaged masonry of the culvert upstream headwall and canal training wall should be reinforced.
7. Additional boulders for energy dissipation should be placed at the right side of the spillway apron and other suitable measures should be undertaken to prevent erosion of the spillway downstream channel bank.

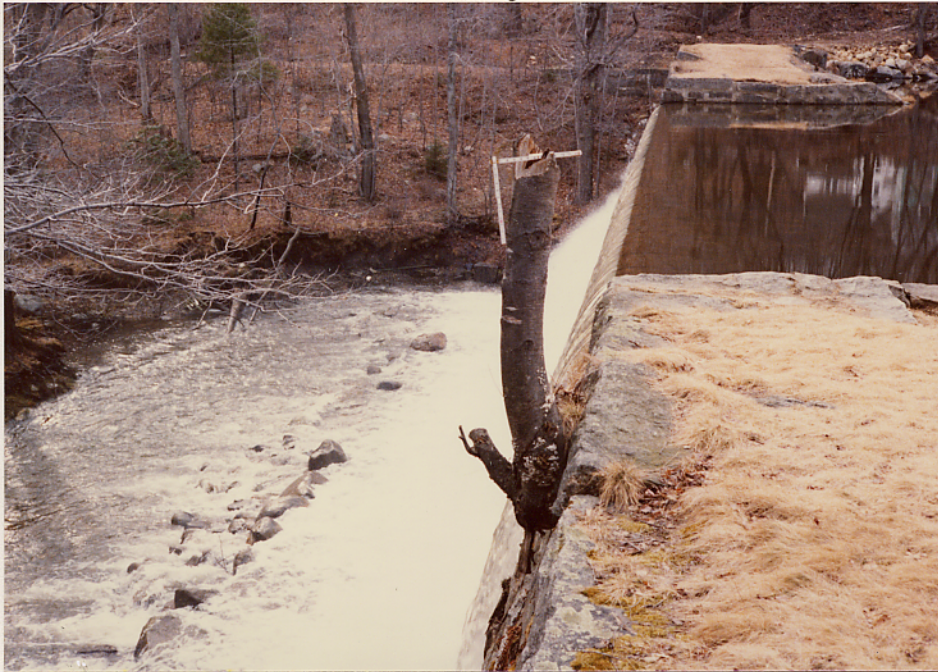
Spillway - The masonry spillway crest is in good condition. No substantial obstructions of the approach channel or crest were observed (Photos 1 and 2). The training walls adjacent to the spillway crest were cracked, with joint openings between blocks of up to 2 inches. The concrete apron at the toe of the spillway could not be observed, due to the amount of water flowing onto it from over the spillway. The energy dissipation boulders on the apron were sparse towards the right side of the channel and, consequently, there is extensive erosion and uprooted trees along the right side of the downstream channel (Photos 2 and 5).

Photo 2 - Spillway and spillway discharge apron. Note tree stump and uplifted masonry block in foreground (3/24/80).

5. Cracks in the masonry of the spillway training walls adjacent to the spillway crest and in the mortared riprap of the upstream slope of the right dam section should be sealed.

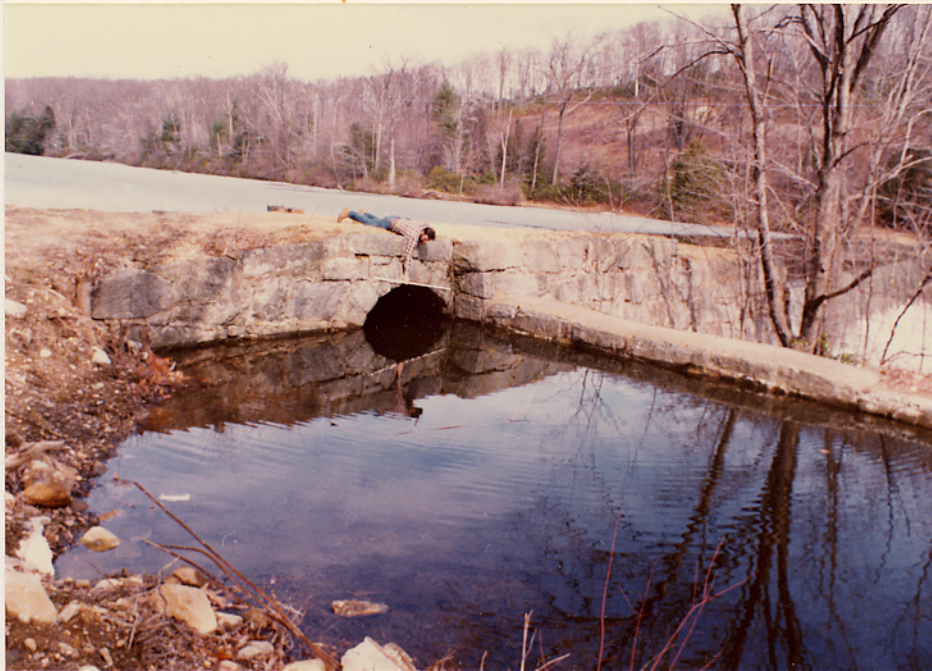
Photo 3 - Downstream headwall of arch culvert and masonry canal wall (3/24/80).

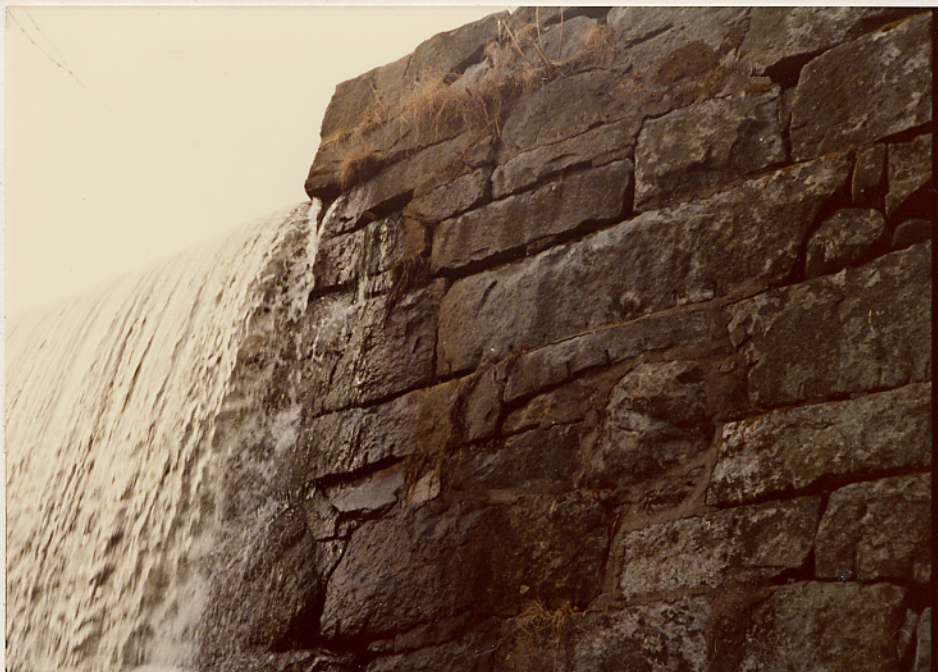
Downstream Face - The masonry downstream face of the dam is mortared on the right embankment, but not on the left. Deteriorated masonry was observed on the downstream face of both embankment sections at a distance of 2 to 4 feet from the edges of the spillway. At these areas the mortar between the blocks is weathered and washed out. Water was observed to be flowing through the joints of the left masonry face at a rate of approximately 6 to 10 gallons per minute (Photo 4). A tree stump, 4 inches in diameter, was noted at the left section near the top of the dam causing a masonry block to be uplifted at this area (Photo 2). Some grass growing from the masonry joints was observed. The toe of the dam is a very heavily wooded area with brush and trees just behind the downstream face (Photo 5).

Photo 4 - Seepage from downstream face of left embankment adjacent to spillway (3/24/80).

3. A comprehensive program of inspection by a registered professional engineer qualified in dam inspection should be instituted on an annual basis.
4. Deteriorated masonry of the downstream face of the embankments adjacent to the spillway should be repaired.

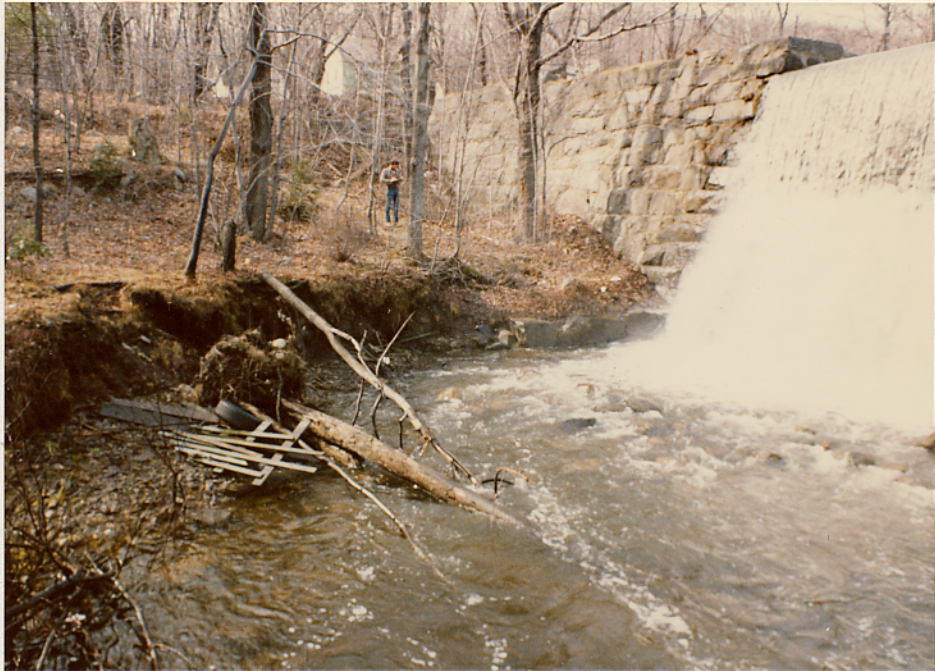
Photo 5-Downstream face of right embankment. Note trees near toe of embankment and erosion of channel bank (3/24/80).

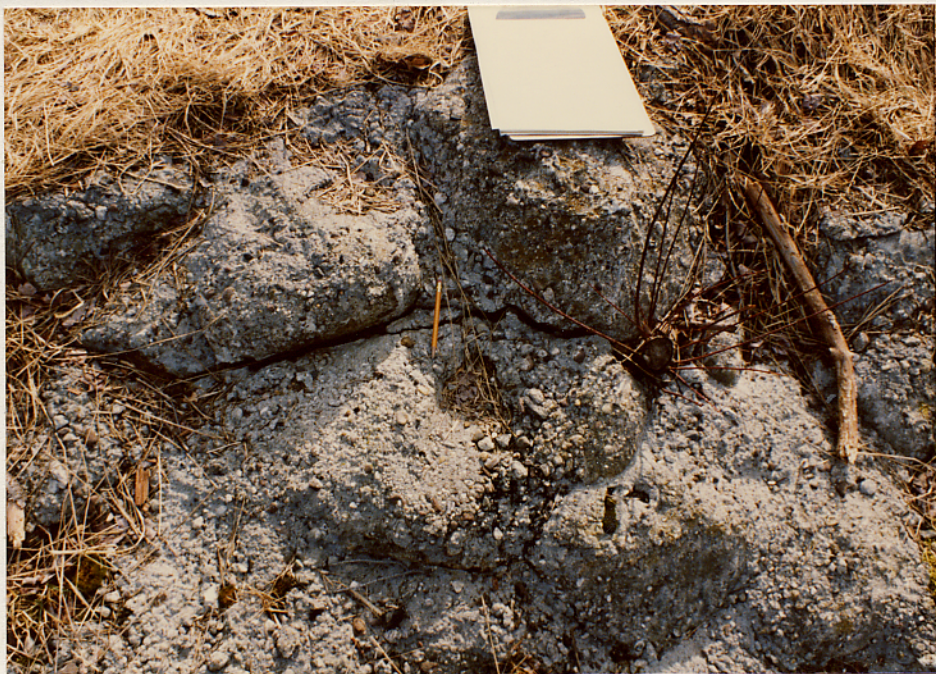
Upstream Slope - The upstream slope riprap, held in place by mortar, is slightly eroded and the mortar is cracked in places (Photo 6). Brush and saplings on the slope were noted on the left embankment.

Photo 6 - Cracked mortar of upstream slope riprap. Note small stump with new growth (3/24/80).
